**PROFESSIONAL ENGINEERING INSPECTIONS, INC.**

Re: 4321 Blastoff Lane, Lazy, Texas

STRUCTURAL INSPECTION REPORT

Mr. Sam Sample  
4321 Blastoff Lane  
Lazy, Texas  
November 31, 2002

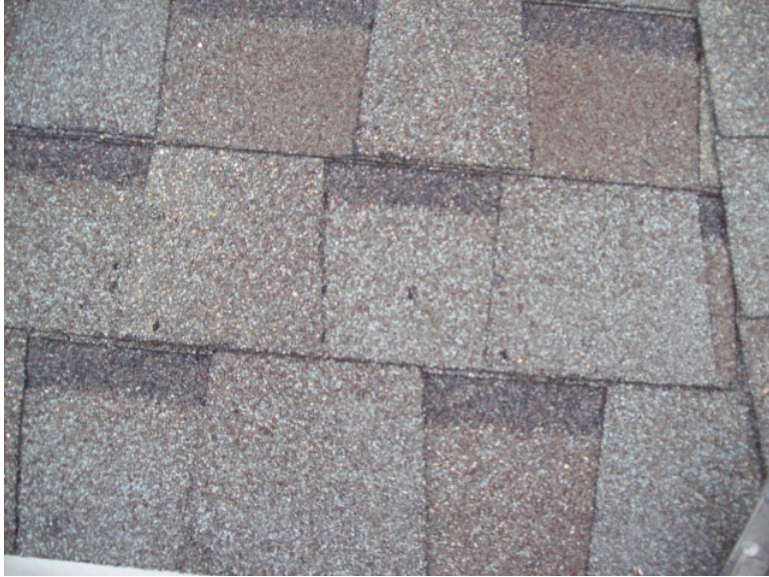
3. Nail holes could be observed through the composition shingles at some locations at the roof, including over the area of the bay windows at the dining room. Nail holes should be identified at the roof and repaired by replacing the shingles due to the young age of the roof to prevent water penetration through the roof at these locations. This appears to be a builder's defect caused during installation of the roof or surrounding finish work. Reference Photograph 1

1. Nail holes could be observed through the composition shingles at some locations at the roof, including over the area of the bay windows at the dining room. Nail holes should be identified at the roof and repaired by replacing the shingles due to the young age of the roof to prevent water penetration through the roof at these locations.

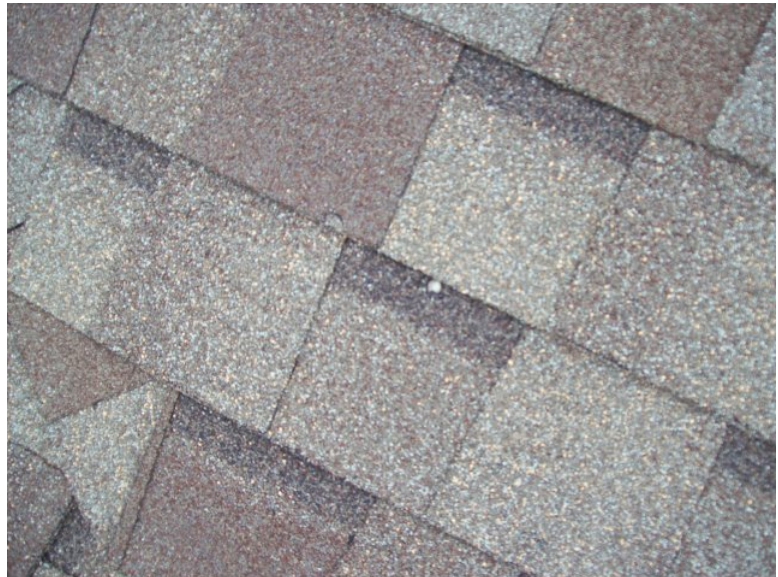
4. Nails were driven exposed through the composition shingles at locations, including over the area of the dining room. This creates a potential for leaks to occur through the roof and should be repaired. Reference Photograph 2

2. Nails were driven exposed through the composition shingles at locations, including over the area of the dining room. This creates a potential for leaks to occur through the roof and should be repaired.

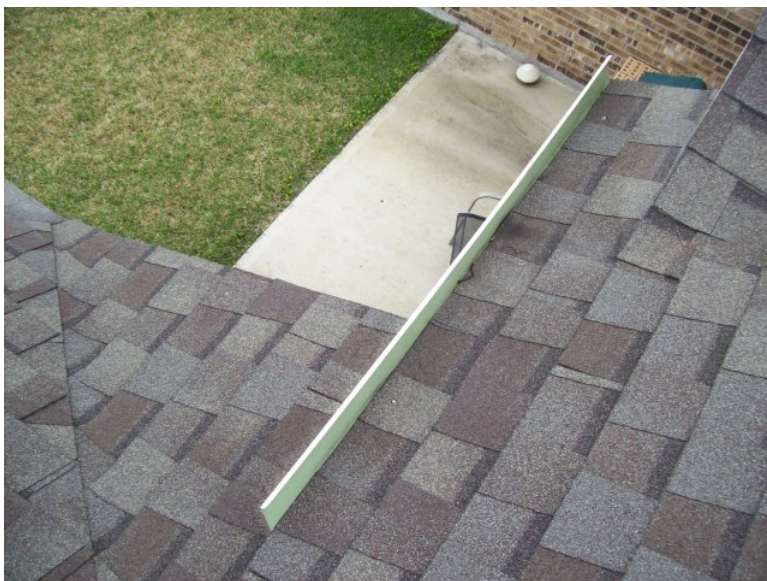
5. Edge dams had been installed along the lower edges of the roof over the condensing unit and over the rear porch. The fasteners used to secure the edge dams in place were driven exposed, creating a greater potential for leaks to occur around the fastener locations. It is generally more desirable to use gutters for this purpose than to use edge dams since debris and water can build up at the edge dams, increasing the potential for water entry. Reference Photograph 3

3. Edge dams had been installed along the lower edges of the roof over the condensing unit and over the rear porch. The fasteners used to secure the edge dams in place were driven exposed, creating a greater potential for leaks to occur around the fastener locations.

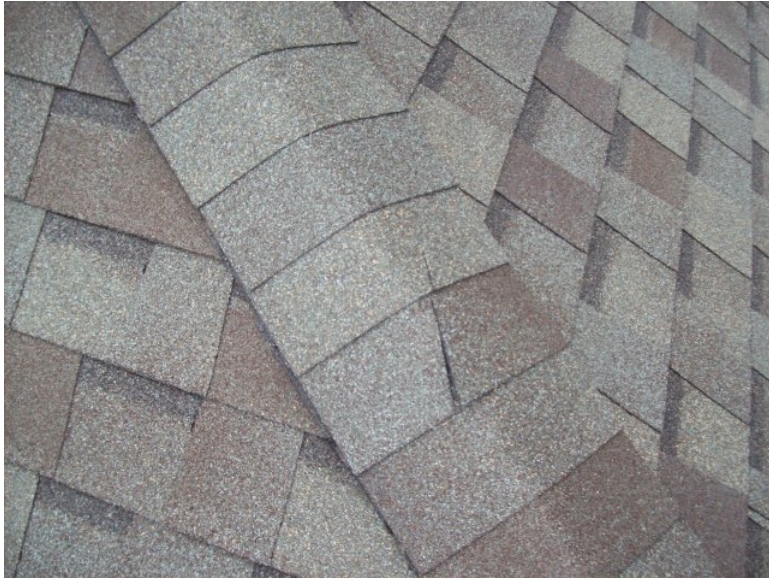
6. Ridge shingles were damaged at the southwest ridge, where it appeared that they were cut through, probably during installation of the roof. The damaged shingles should be replaced to reduce the potential for further damage to the ridge during high winds. Reference Photograph 4

- 4. Ridge shingles were damaged at the southwest ridge, where it appeared that they were cut through, probably during installation of the roof. The damaged shingles should be replaced to reduce the potential for further damage to the ridge during high winds.

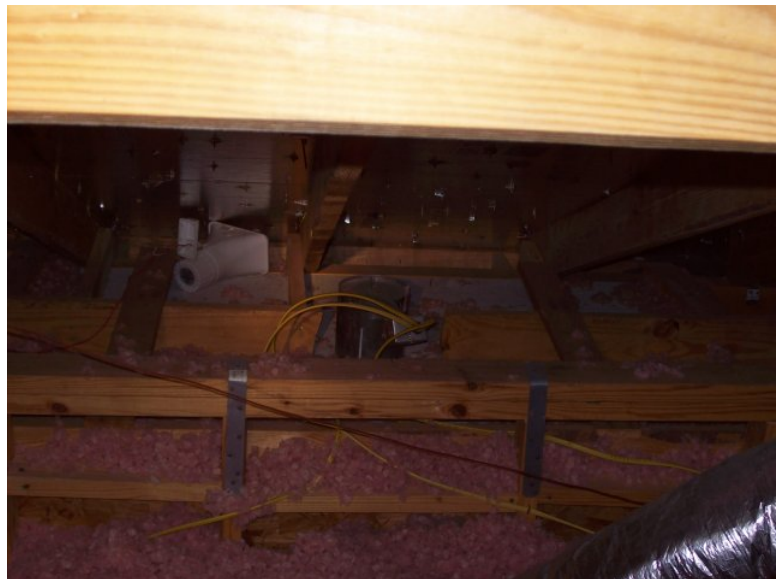
- 5. Ceiling joists over the front porch were cut through for installation of the light fixture. The ceiling appeared to be performing satisfactorily; however, cut joists are normally crippled to the adjacent joist to reduce the potential for sagging.

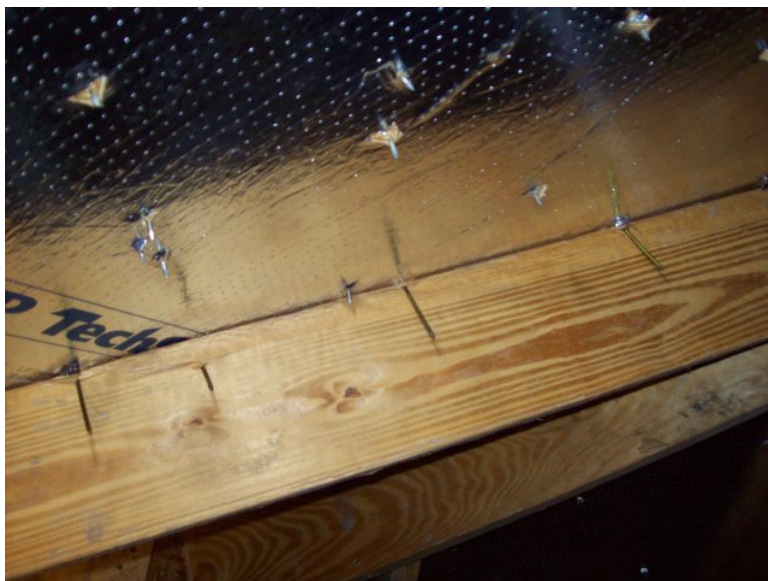
4. Nails used to secure the roof decking to the roof rafters missed the rafters at some locations, with the most significant areas occurring at the south roof, although this condition existed at random locations. This can reduce the roof's resistance to wind load if additional fasteners were not added during installation to properly engage the framing. Decking at the south roof over the area of the dining room appeared to be slightly loose to the rafter, indicating additional fasteners may not have been installed. This can be repaired when the roof is replaced the next time. Reference Photograph 6

- 6. Nails used to secure the roof decking to the roof rafters missed the rafters at some locations, with the most significant areas occurring at the south roof, although this condition existed at random locations.

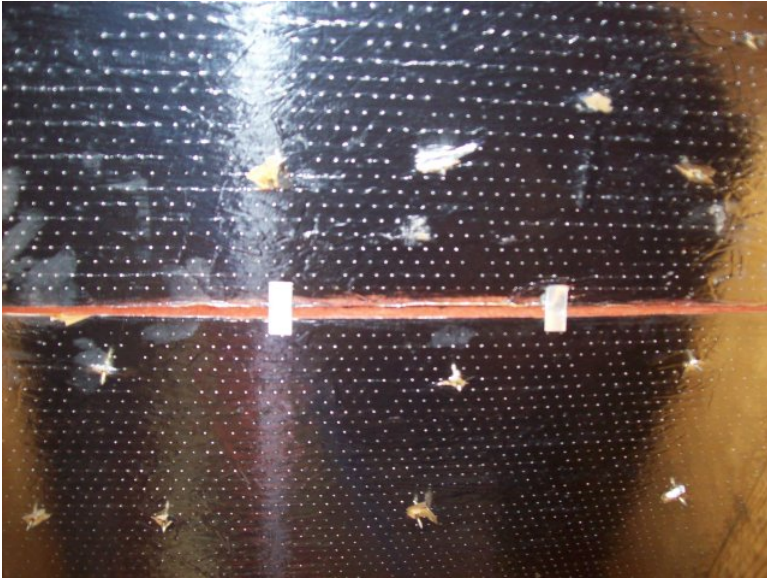
- 7. Roof decking was slightly uneven at some locations, including over the attic access opening. Misalignment of the decking can cause ridges to occur in the roof and sometimes occurs due to poor spacing during installation of the deck.

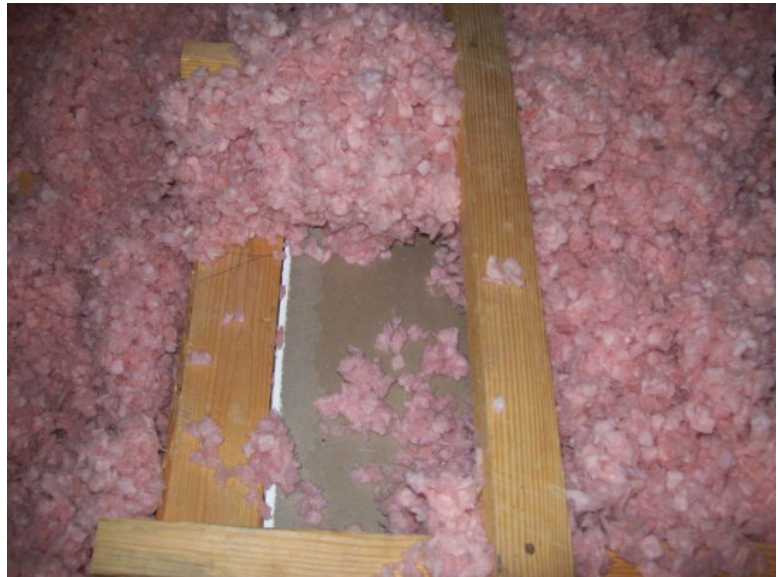
2. The attic insulation was observed to be missing or out of place at the study ceiling and vertical walls at the living room, which can result in loss of energy. The insulation should be replaced. Reference Photograph 8

- 8. The attic insulation was observed to be missing or out of place at the study ceiling and vertical walls at the living room, which can result in loss of energy.

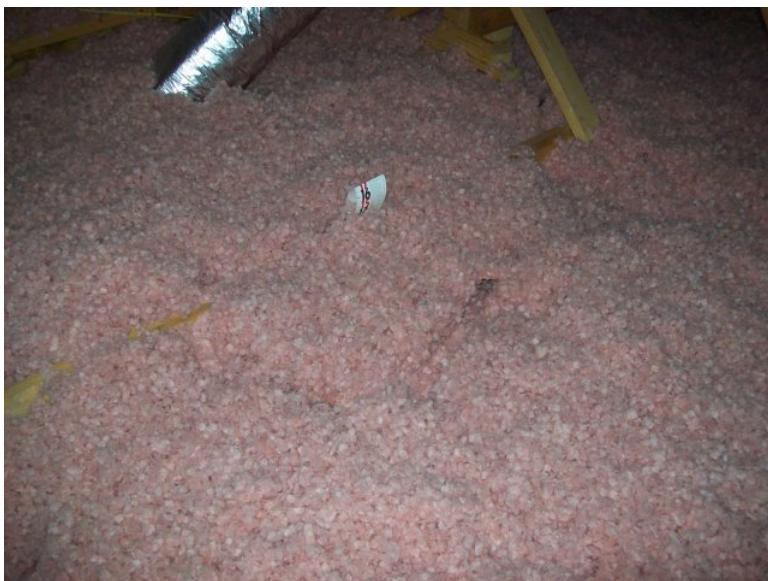
- 9. There was evidence of animal access in the attic space, where the animals may have gained access through gaps at the soffits. This was indicated by trails through the insulation.

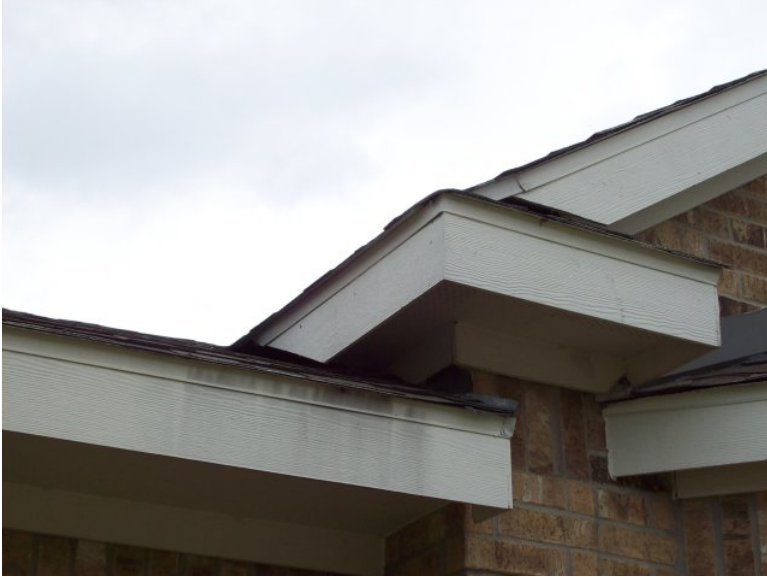
6. Larger than normal gaps could be observed between the soffit, fascia and roof at some locations, including at the south roof around the area of the dining room gable and at the north roof at the living room gable. Refitting of the cornice work is necessary so that it is in contact or very near contacting the roof surface so that animals cannot nest in the soffits or gain access to the attic. Reference Photograph 10

10. Larger than normal gaps could be observed between the soffit, fascia and roof at some locations, including at the south roof around the area of the dining room gable and at the north roof at the living room gable. Refitting of the cornice work is necessary so that it is in contact or very near contacting the roof surface so that animals cannot nest in the soffits or gain access to the attic.

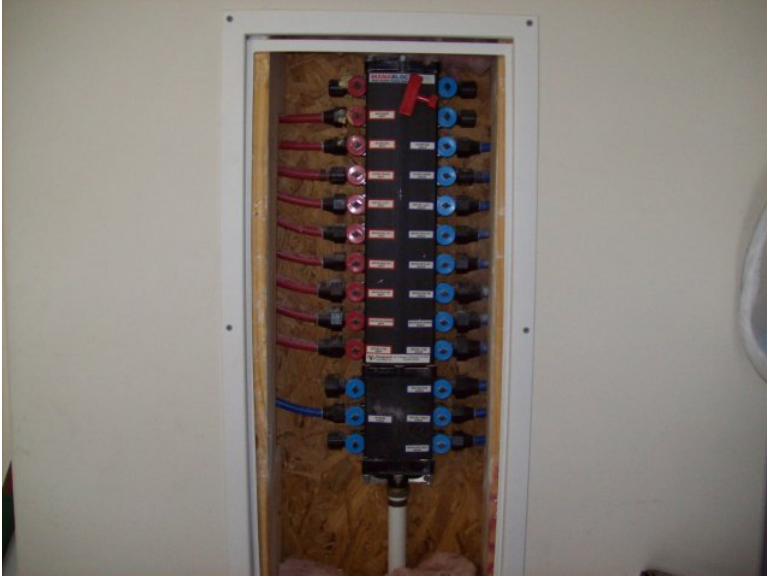
1. The manifold control for the PEX water distribution system was located at the north wall of the garage. This is the location where individual fixtures can be controlled in order to turn them on and off for servicing or repair.

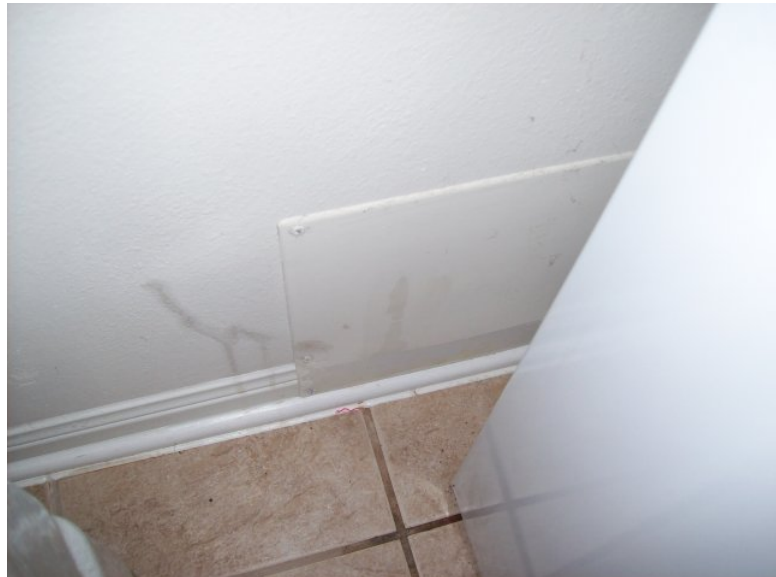
2. There was an access opening cover installed below the washing machine connections on the wall near the floor in the utility room. It was not determined what the cover was protecting, and further investigation would require removal of the cover.

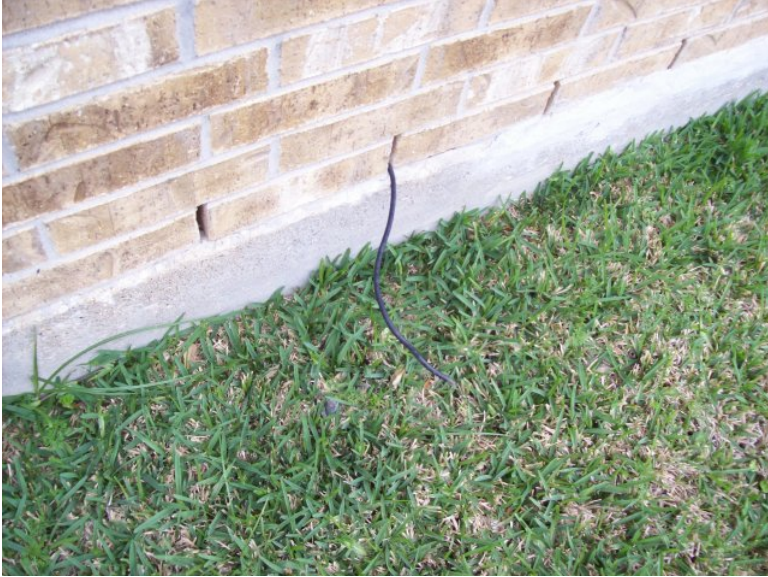
1. The earth ground was not connected or was loose from the ground rod that provides a ground for the breaker panel box.

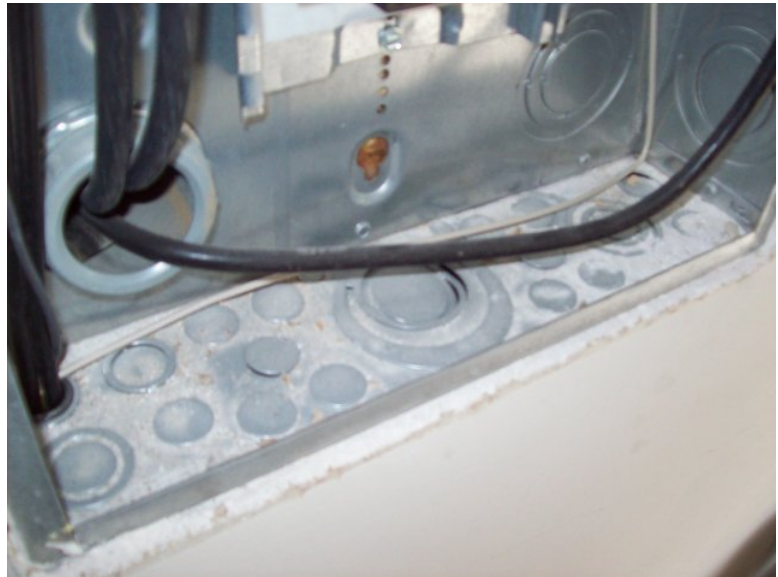
2. Some of the knockouts at the bottom of the panel box were pushed out partially, leaving gaps. It is normally desirable for the knockouts to be in good conditions to help retain a fire that might start in the panel box from spreading to the wall cavity.

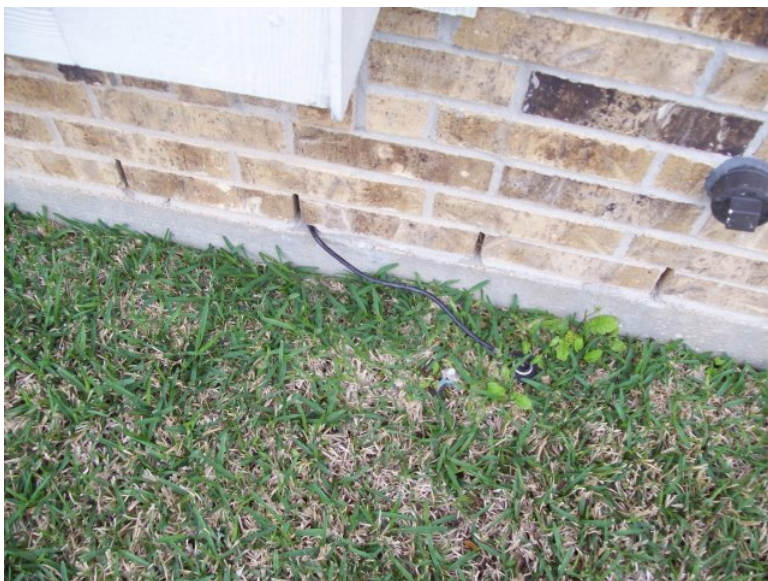
3. The bonding wire for the master bath whirlpool tub was disconnected from the grounding rod installed at the exterior of the bathroom.
